**Flood Control Project Maintenance
Levee Inspections**

Maintenance Issue Types Only, Levee Inspection Report By Mile - Spring 2019

Reclamation District No. 0404 Boggs

Waterway	Bank	Unit Miles	Inspection Start/End	Inspector
Unit No. 01 San Joaquin River	Right	2.35	04/23/2019 04/23/2019	Alberto De Leon

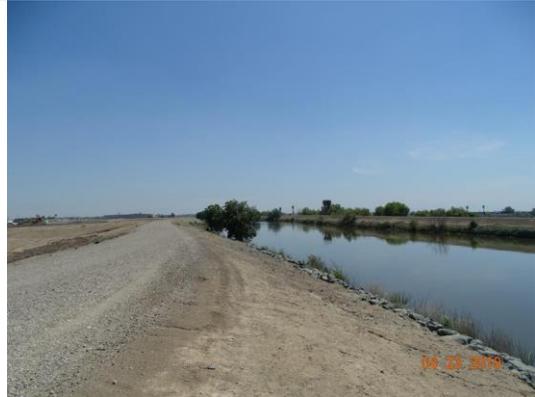
Photo 1 of 1 : SP_2019_RD0404_305_30_20190430_00058.jpg

LM Start	0.00	Rating **	A	Issue No.	30
LM End	2.35	Issue Type +	Ma	Location *	WS
Category	Earthen Levee		GPS Latitude/Longitude		
			Start	End	
Item	Vegetation		37.942171 °	37.920337 °	
			-121.345177 °	-121.318377 °	
DWR ID	DWR_RD0404_01_s_2019_30				
Comment Code					
V1 : Control annual grass and weeds on the levee slopes and easements.					
Inspector Comment					
Annual vegetation is well maintained.

Typical view of vegetation on waterside slope. (Spring 2019)

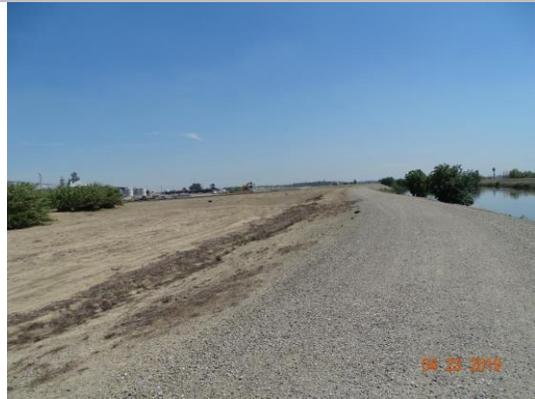
Photo 1 of 1 : SP_2019_RD0404_305_28_20190430_00059.jpg

LM Start	0.00	Rating **	A	Issue No.	28
LM End	2.35	Issue Type +	Ma	Location *	LS
Category	Earthen Levee		GPS Latitude/Longitude		
			Start	End	
Item	Vegetation		37.942179 °	37.920333 °	
			-121.345183 °	-121.318376 °	
DWR ID	DWR_RD0404_01_s_2019_28				
Comment Code					
V1 : Control annual grass and weeds on the levee slopes and easements.					
Inspector Comment					
Annual vegetation is well maintained.

Typical view of vegetation on landside slope. (Spring 2019)

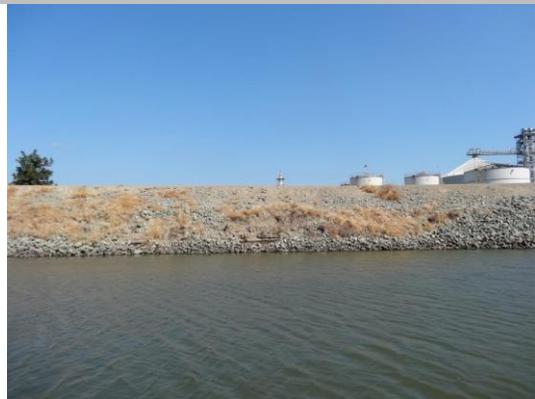
Photo 1 of 3 : SP_2019_RD0404_305_6_20190313_00001.jpg

LM Start	0.40	Rating **	M	Issue No.	6
LM End	0.41	Issue Type +	Ma	Location *	WS
Category	Supplemental		GPS Latitude/Longitude		
			Start	End	
Item	DWR Erosion Survey		37.939534 °	37.939534 °	
			-121.339562 °	-121.339562 °	
DWR ID	RD0404U01RM41.05				
Comment Code					
Inspector Comment					
09/13/2017: The erosion is located between two protected levee sections. [2017 Site ID:RD0404U01RM41.05]

Front view of the erosion.

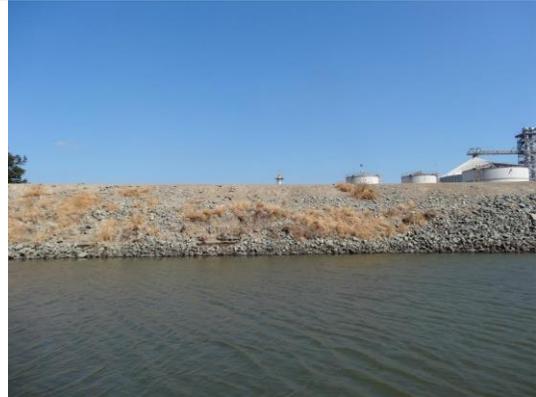
Photo 2 of 3 : SP_2019_RD0404_305_6_20190313_00002.jpg

Front of the erosion.

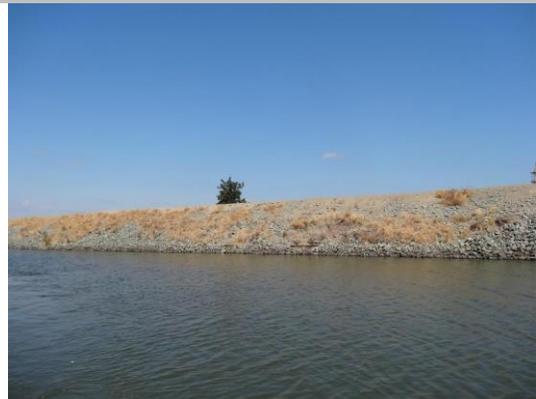
Photo 3 of 3 : SP_2019_RD0404_305_6_20190313_00003.jpg

Looking downstream at the erosion site.

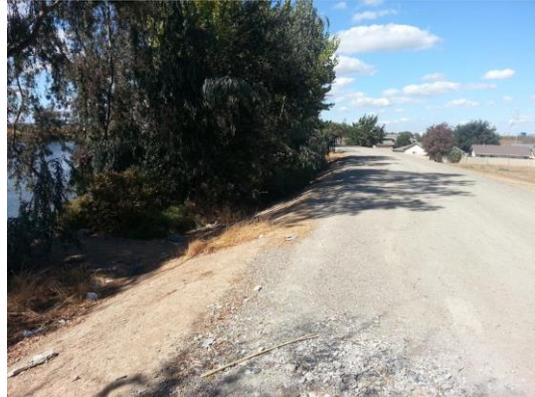
Photo 1 of 1 : SP_2019_RD0404_305_100_20190313_00020.jpg

Looking northwest at untrimmed trees on waterward slope.

LM Start	1.35	Rating **	M	Issue No.	100
LM End	1.35	Issue Type +	Ma	Location *	WS
Category	Earthen Levee		GPS Latitude/Longitude		
			Start	End	
Item	Trim / Thin Trees		37.931945 °	37.931945 °	
			-121.327150 °	-121.327150 °	
DWR ID	DWR_RD0404_01_s_2012_100				
Comment Code					
T1 : Trim trees to at least five feet above ground level.					
Inspector Comment

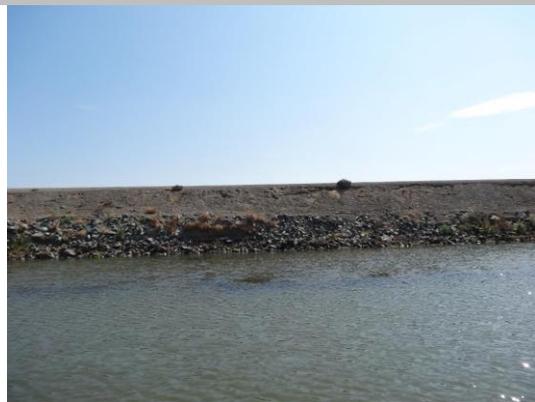
Photo 1 of 2 : SP_2019_RD0404_305_11_20190313_00005.jpg

LM Start	1.44	Rating **	M	Issue No.	11
LM End	1.46	Issue Type +	Ma	Location *	WS
Category	Supplemental		GPS Latitude/Longitude		
			Start	End	
Item	DWR Erosion Survey		37.930450 °	37.930450 °	
			-121.327450 °	-121.327450 °	
DWR ID	RD0404U01RM42.02				
Comment Code					
Inspector Comment					
09/13/2017: No significant change observed. 07/25/2016: No significant change observed. 06/24/2015: No significant change observed. 06/19/2014: A series of scarp erosions have been found on the lower levee slope and at the levee toe. [2017 Site ID:RD0404U01RM42.02]

Front view of the erosion.

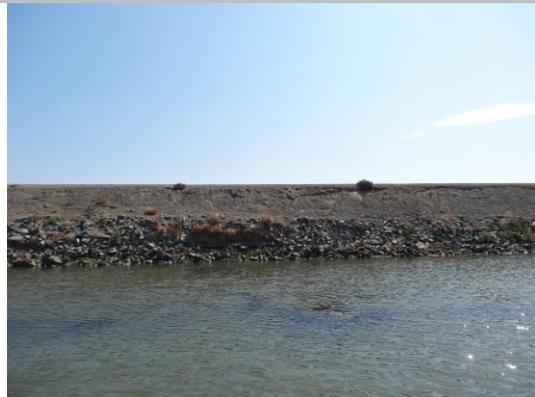
Photo 2 of 2 : SP_2019_RD0404_305_11_20190313_00006.jpg

Close view of the erosion. Note the protection on the lower levee slope.

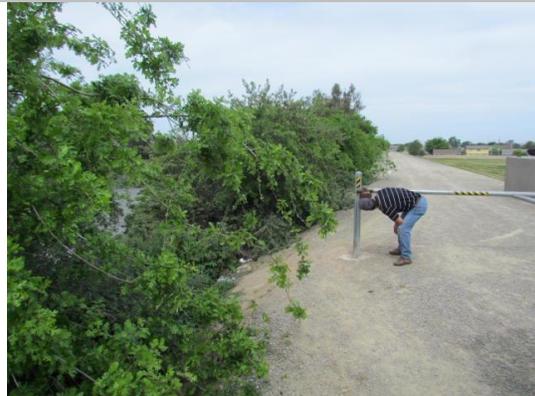
Photo 1 of 2 : SP_2019_RD0404_305_29_20190313_00014.jpg

LM Start	1.70	Rating **	A/W	Issue No.	29
LM End	1.77	Issue Type +	Ma	Location *	WS
Category	Earthen Levee		GPS Latitude/Longitude		
			Start	End	
Item	Trim / Thin Trees		37.927517 °	37.926632 °	
			-121.325515 °	-121.324868 °	
DWR ID	DWR_RD0404_01_s_2015_29				
Comment Code					
T1 : Trim trees to at least five feet above ground level.					
Inspector Comment					
Dense untrimmed trees are on the waterward slope. This is an Army Corp veg site. Tree and woody vegetation was planted by DWR but not being maintained according to the agreement.

Looking north at dense vegetation on waterward slope.

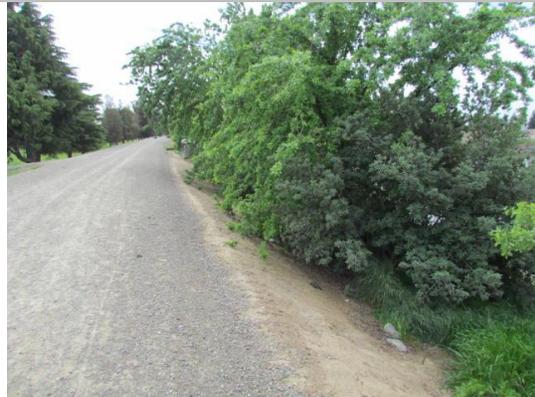
Photo 2 of 2 : SP_2019_RD0404_305_29_20190313_00015.jpg

Looking south at dense vegetation on waterward slope.

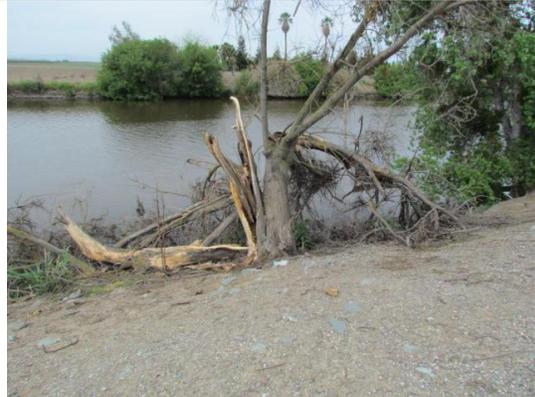
Photo 1 of 1 : SP_2019_RD0404_305_33_20190313_00016.jpg

LM Start	2.00	Rating **	U	Issue No.	33
LM End	2.00	Issue Type +	Ma	Location *	WS
Category	Earthen Levee		GPS Latitude/Longitude		
			Start	End	
Item	Encroachments		37.923673 °	37.923673 °	
			-121.323015 °	-121.323015 °	
DWR ID	DWR_RD0404_01_s_2016_33				
Comment Code					
TR : Tree or limb					
Inspector Comment					
There is a dead tree on the waterward slope that needs to be removed.

Looking west at dead tree on waterward slope.

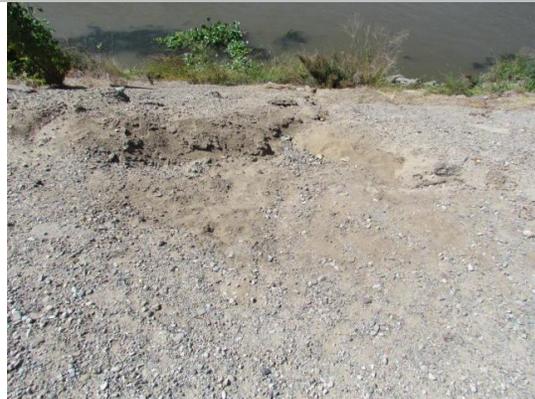
Photo 1 of 2 : SP_2019_RD0404_305_16_20190313_00008.jpg

LM Start	2.01	Rating **	M	Issue No.	16
LM End	2.01	Issue Type +	Ma	Location *	WS
Category	Earthen Levee		GPS Latitude/Longitude		
			Start	End	
Item	Slope Stability		37.923470 °	37.923470 °	
			-121.322978 °	-121.322978 °	
DWR ID	DWR_RD0404_01_f_2013_16				
Comment Code					
S2 : Repair the levee slope damaged by foot traffic and prevent access where possible.					
Inspector Comment					
There is slope damage due to foot traffic.

Looking west at slope damage due to foot traffic.

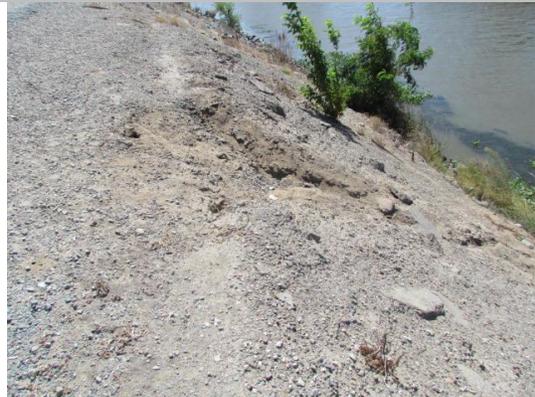
Photo 2 of 2 : SP_2019_RD0404_305_16_20190313_00009.jpg

Looking southwest at slope damage due to foot traffic.

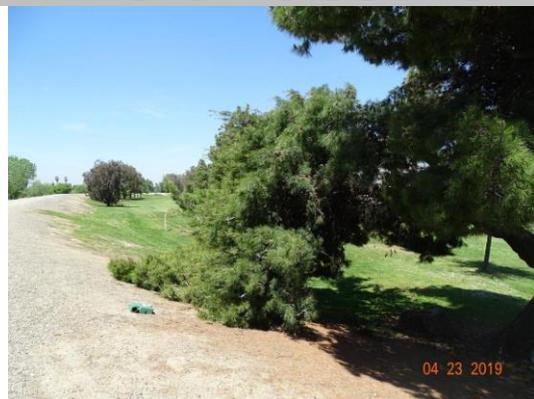
Photo 1 of 1 : SP_2019_RD0404_305_31_20190430_00060.jpg

LM Start	2.25	Rating **	U	Issue No.	31
LM End	2.25	Issue Type +	Ma	Location *	LS
Category	Earthen Levee		GPS Latitude/Longitude		
			Start	End	
Item	Encroachments		37.921089°	37.921089°	
			-121.319880°	-121.319880°	
DWR ID	DWR_RD0404_01_s_2019_31				
Comment Code					
TR : Tree or limb					
Inspector Comment					
There is a broken tree limb on the landside slope impeding access for flood fighting.

Broken large tree limb on landside slope, District Engineer is aware and has scheduled removal. (Spring 2019)

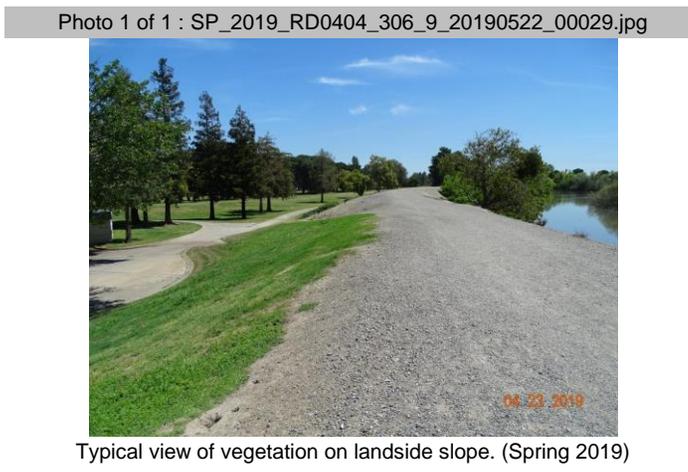
LM Start	0.00	Rating **	A	Issue No.	9
LM End	1.75	Issue Type +	Ma	Location *	LS
Category	Earthen Levee		GPS Latitude/Longitude		
			Start	End	
Item	Vegetation		37.920338 °	37.917284 °	
			-121.318367 °	-121.291740 °	
DWR ID	DWR_RD0404_02_s_2019_9				
Comment Code					
V1 : Control annual grass and weeds on the levee slopes and easements.					
Inspector Comment					
Annual vegetation is well maintained.

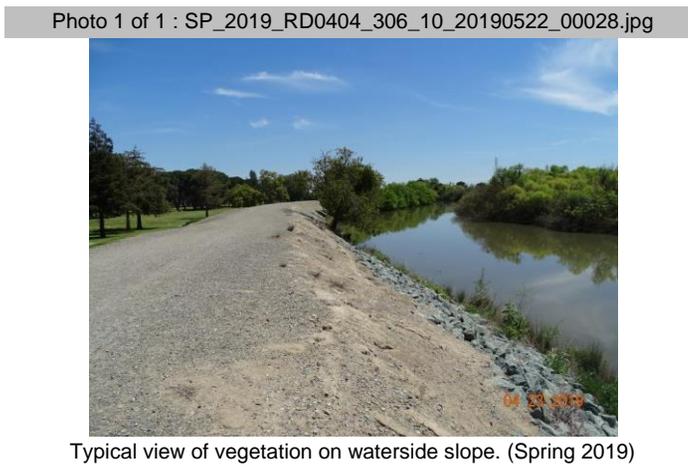
LM Start	0.00	Rating **	A	Issue No.	10
LM End	1.75	Issue Type +	Ma	Location *	WS
Category	Earthen Levee		GPS Latitude/Longitude		
			Start	End	
Item	Vegetation		37.918875 °	37.917284 °	
			-121.316587 °	-121.291740 °	
DWR ID	DWR_RD0404_02_s_2019_10				
Comment Code					
V1 : Control annual grass and weeds on the levee slopes and easements.					
Inspector Comment					
Annual vegetation is well maintained.

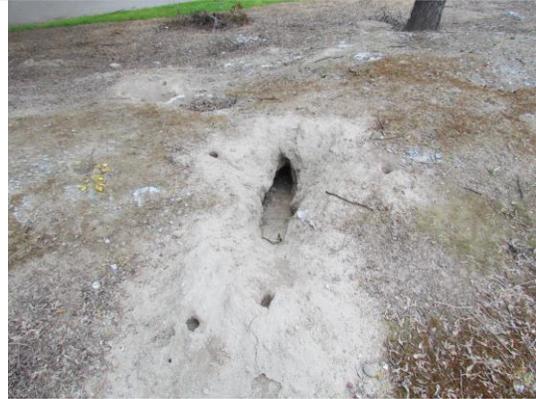
Photo 1 of 3 : SP_2019_RD0404_306_11_20190313_00001.jpg

LM Start	0.16	Rating **	M	Issue No.	11
LM End	0.48	Issue Type +	Ma	Location *	LS
Category	Earthen Levee		GPS Latitude/Longitude		
			Start	End	
Item	Animal Control		37.918671 °	37.919525 °	
			-121.316367 °	-121.311193 °	
DWR ID	DWR_RD0404_02_s_2012_11				
Comment Code					
A3 : No rodents visible, but rodent burrows visible; need to backfill and compact or grout burrows.					
Inspector Comment					
Grouting program is being used but has not been effective.

Looking east at large rodent hole on landward slope.

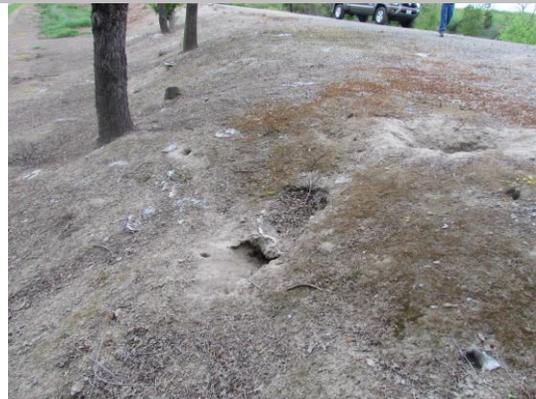
Photo 2 of 3 : SP_2019_RD0404_306_11_20190313_00002.jpg

Looking southwest at several rodent holes on landward slope.

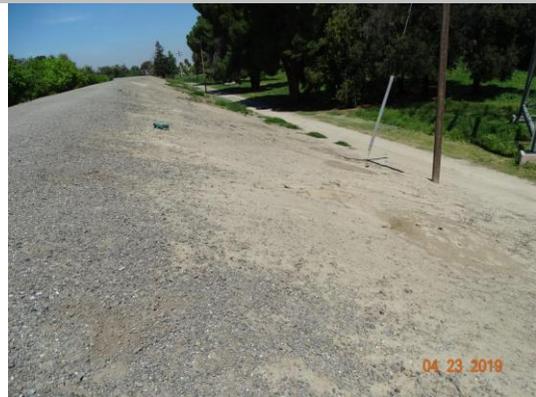
Photo 3 of 3 : SP_2019_RD0404_306_11_20190522_00027.jpg

View of landside slope with multiple rodent holes. Animal control/bait program not effective. (Spring 2019)

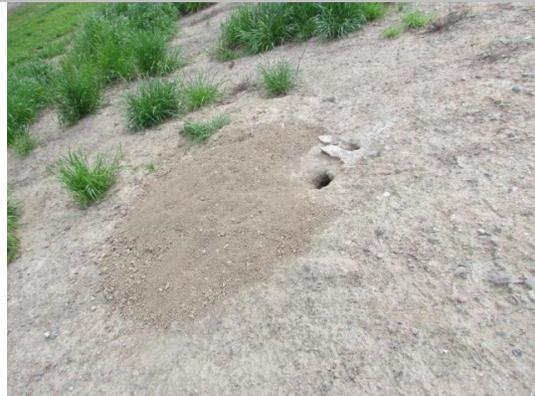
Photo 1 of 2 : SP_2019_RD0404_306_21_20190313_00009.jpg

Looking northeast at large rodent hole on landward slope.

LM Start	0.68	Rating **	U	Issue No.	21
LM End	1.08	Issue Type +	Ma	Location *	LS
Category	Earthen Levee		GPS Latitude/Longitude		
			Start	End	
Item	Animal Control		37.919245 °	37.916383 °	
			-121.307705 °	-121.302802 °	
DWR ID	DWR_RD0404_02_s_2016_21				
Comment Code					
A1 : Exterminate rodents and backfill and compact or grout burrows.					
Inspector Comment

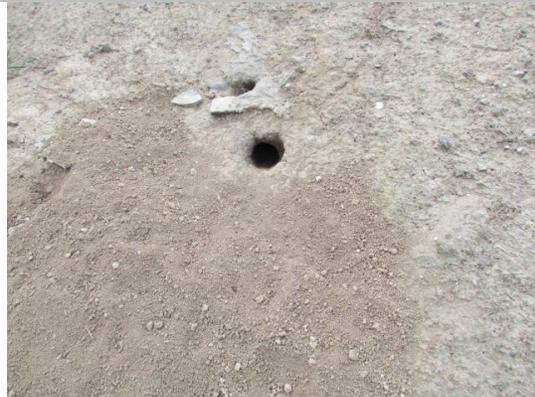
Photo 2 of 2 : SP_2019_RD0404_306_21_20190313_00010.jpg

Looking east at large rodent hole on landward slope.
